The Last Line of Defense - correct and properly fitted laser protective eyewear

Improper Laser Safety Glasses Key Factor In Serious Eye Injury

Unauthorized Modification of a Laser Safety Barrier

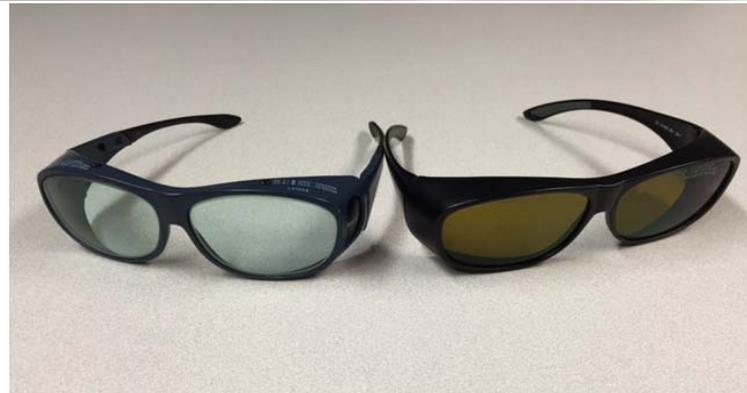
Figure 2. Glass vs. Polycarbonate Eyewear

There are also two types of materials generally used for LPE, glass and polycarbonate. Both have positives and negatives.

Glass is able to withstand high intensity beams, but is generally heavy and limited in frame styles. It is also NOT impact resistant, limiting its use in many environments.

Polycarbonate, on the other hand, is lightweight, can generally be formed into many different frame styles,

and is impact safe. The negative is that a laser beam can burn through the filter media.

Remember this when you are setting up a high power laser and you choose polycarbonate eyewear as your last line of defense. This eyewear was never intended to take a direct hit from a laser beam, i.e., looking directly into the laser.

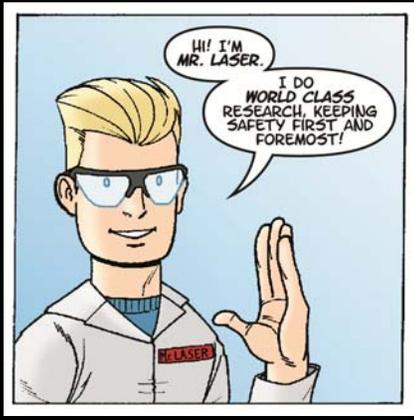
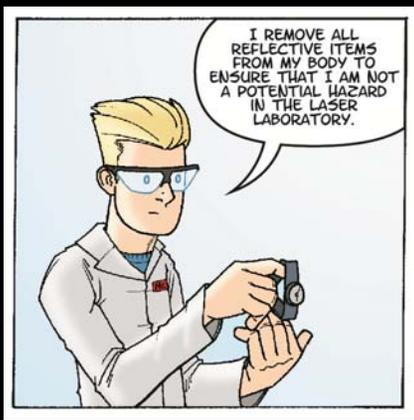
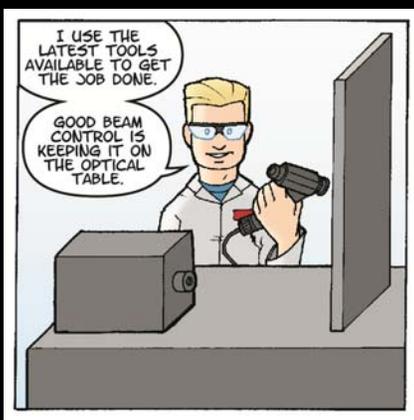
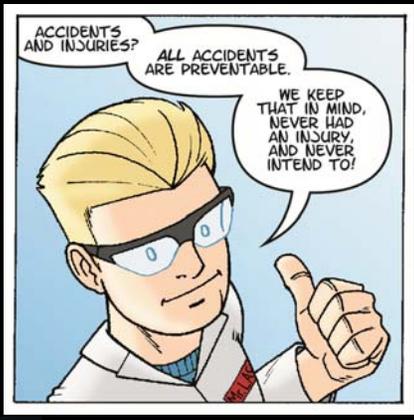
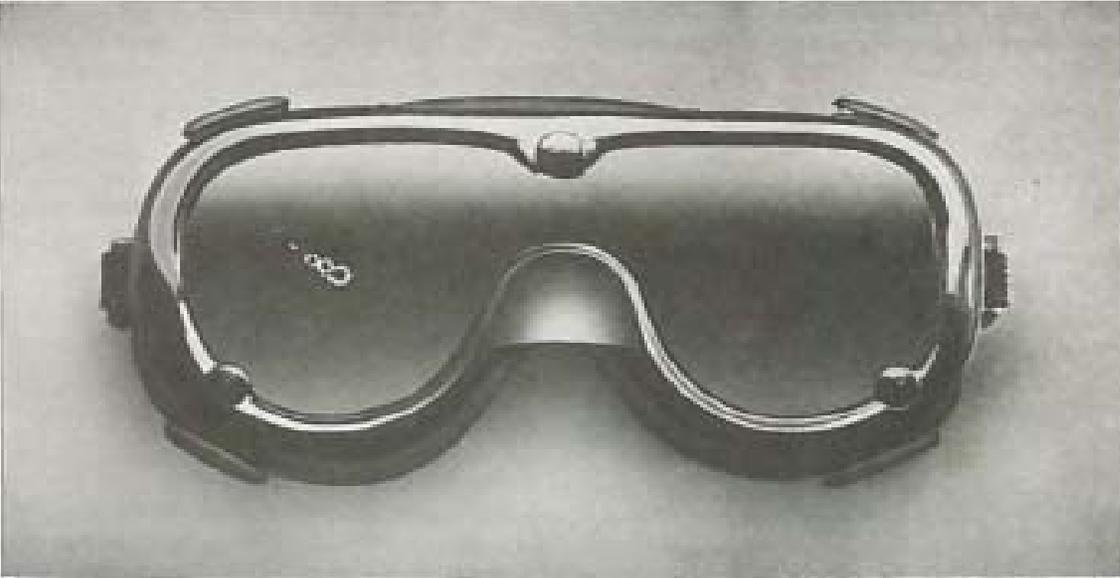
A laser scientist's right retina was severely burned by a 1.06 micrometer repetitively pulsed laser beam that melted a hole through the Laboratory-approved plastic laser safety goggles he was wearing. With full knowledge that the laser beam was on and passing through the cell that contained his experiment, the scientist looked directly into the cell. He said afterward that he had had confi-

The 1 micrometer laser beam presented a very severe eye hazard (~10E6 x Maximum Permissible Exposure) and a serious skin hazard (200 x Maximum Permissible Exposure). The injury was described as a 400 micrometer diameter crater burned into the retina of his right eye surrounded by a 3 millimeter diameter trauma region near the center of the field of vision.

Figure 3. These plastic laser safety goggles failed when an experimenter looked directly into a repetitively pulsed laser beam. Although laser beams should not be viewed directly, and the goggle frames carried a warning against doing so, the consequences would have been less severe had he been wearing filter-glass goggles. Filter-glass safety goggles should be worn when working in laboratories where there are high-peak-power and high-average-power (repetitively pulsed or continuous wave) lasers. should not be worn by people who might be exposed to reflections or glints from such beams.

high-peak power and high-average power beams are not documented. After the accident, however, several pairs of plastic-lens goggles similar to those the scientist was wearing were tested in the laser beam at the location where the victim's had failed and at three other locations at higher specific powers. Safety glasses made of KG-3 filter glass, non-prescription, also were tested at the same locations. The plastic goggles were penetrated in 25- 35 seconds with a beam of 1.06 micrometer light operating at a specific power of 16 watts per square centimeter: the filter glass goggles survived the same beam operating at a specific power of 70 watts per square centimeter for 5 minutes with no damage, although they were hot to the touch. Clearly there is a big difference between these two types of eyewear in their capacities to handle high-average power laser beams. The injury would not have occurred had the employee been wearing filter-glass eye protection.

The problem here was lack of implementing controls that would have prevented the individual from looking directly into the laser beam.

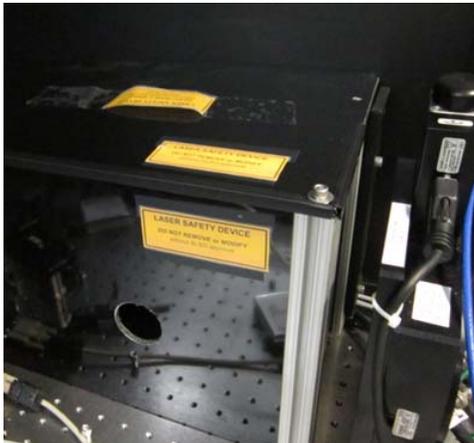
Figure 4: Shutter enclosure for the dual Exit Shutters

The user's alignment laser work was with the area in Laser Off Mode. The user wanted to transport the laser beam from the end station back through an optics path inside the table enclosure that would later be used for the high power beam, but was prevented from doing this by the dual Exit Shutters. These shutters are located inside a shutter enclosure, shown in Figure 4, that is inside the large table enclosure.

The Exit Shutters and the associated shutter enclosure are secured and affixed with labels stating, "Laser Safety Device – Do Not Remove or Modify without SLSO Approval." SLSO is an acronym for the System Laser Safety Officer. To perform the desired work, the user should have consulted with the SLSO, who would have arranged for this to be done with the area in the Laser Off – Alignment mode. However, the user did not do this! Because the Hutch was in Laser Off mode, the user did not consider it would be unsafe to remove the shutter enclosure panel and prop open the 2 Exit Shutters. The user acknowledged reading the safety labels but did not perceive these actions as unsafe because of the Laser Off operation mode. When the user lifted the shutter blade, the engineered laser safety system generated a "shutter inconsistent state" interlock fault and sounded an audible alarm. This resulted in notification to an area manager and the SLSO, who subsequently found that a laser safety barrier had been modified without proper authorization.

Lab management for the DOE facility investigated the incident and determined the unauthorized modification of the laser safety shutter/enclosure to be a significant event, and submitted a notification to DOE's ORPS reporting system. Corrective actions taken included: verification that the Exit Shutters and associated shutter enclosure were properly installed, configured, and secured; a reprimand letter from lab management to the user stating that tampering with a safety system is unacceptable and that willful disregard for adherence to safety policy will not be tolerated; and review of experimental area orientation procedures for adequate training on safety system configuration control.
